HISTORIC STRUCTURE REPORT

FORT MATANZAS NATIONAL MONUMENT
ST. JOHN'S COUNTY, FLORIDA

THE FORT MATANZAS STABILIZATION TEAM

DENVER SERVICE CENTER
SOUTHEAST/SOUTHWEST TEAM
HISTORIC PRESERVATION BRANCH
NATIONAL PARK SERVICE
UNITED STATES DEPARTMENT OF THE INTERIOR
DENVER, COLORADO

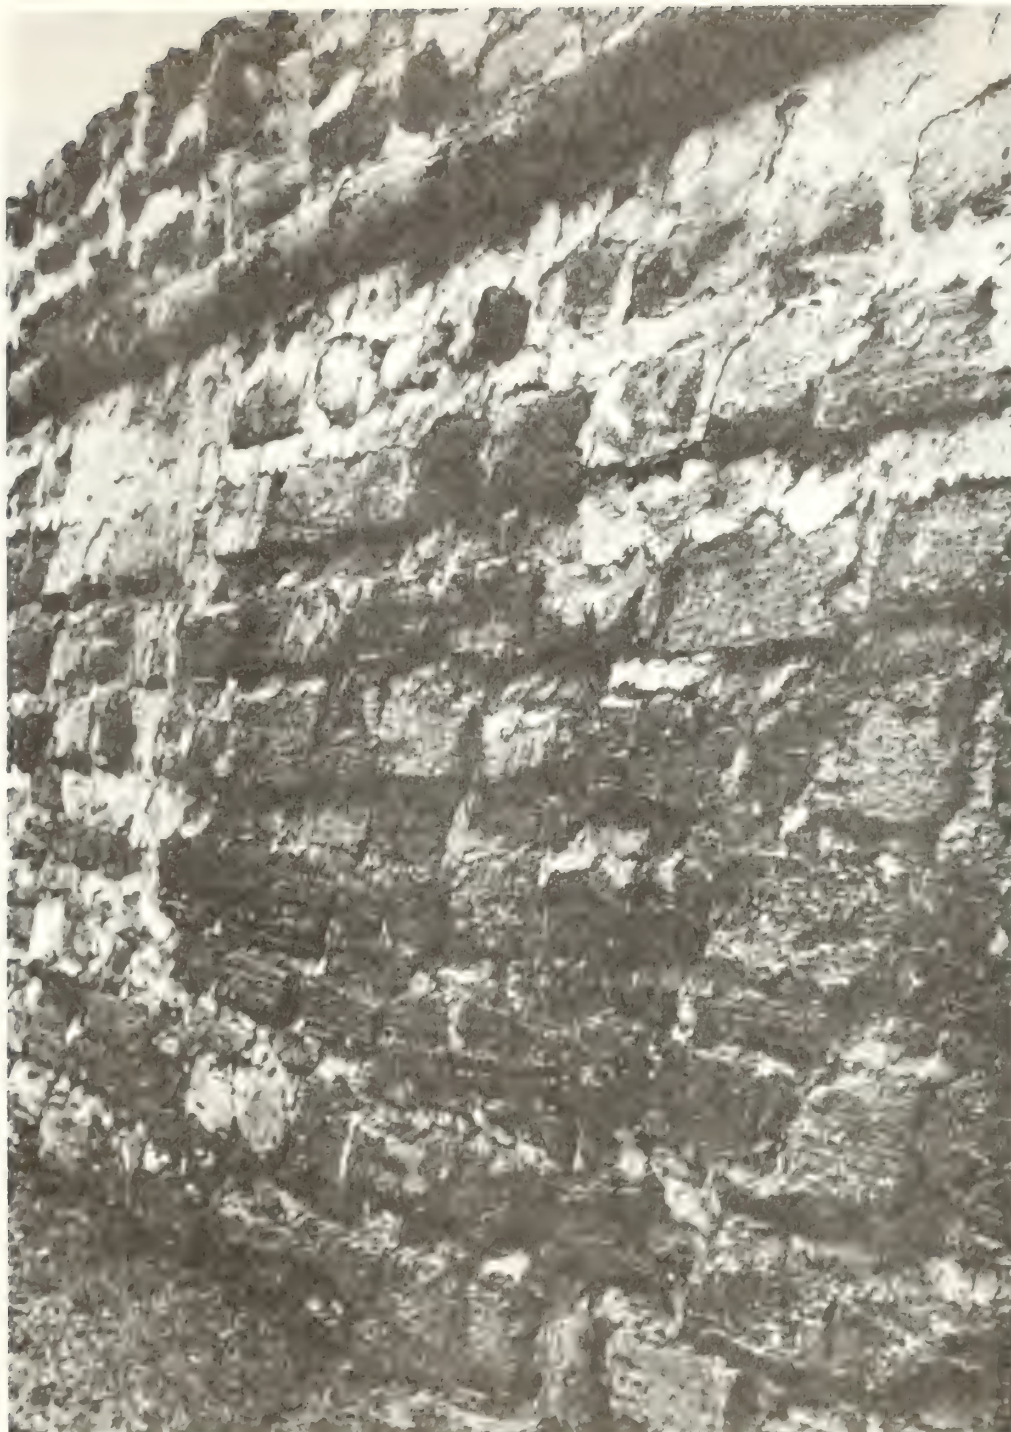
Illustration 19

Detail of South Scarp Erosion

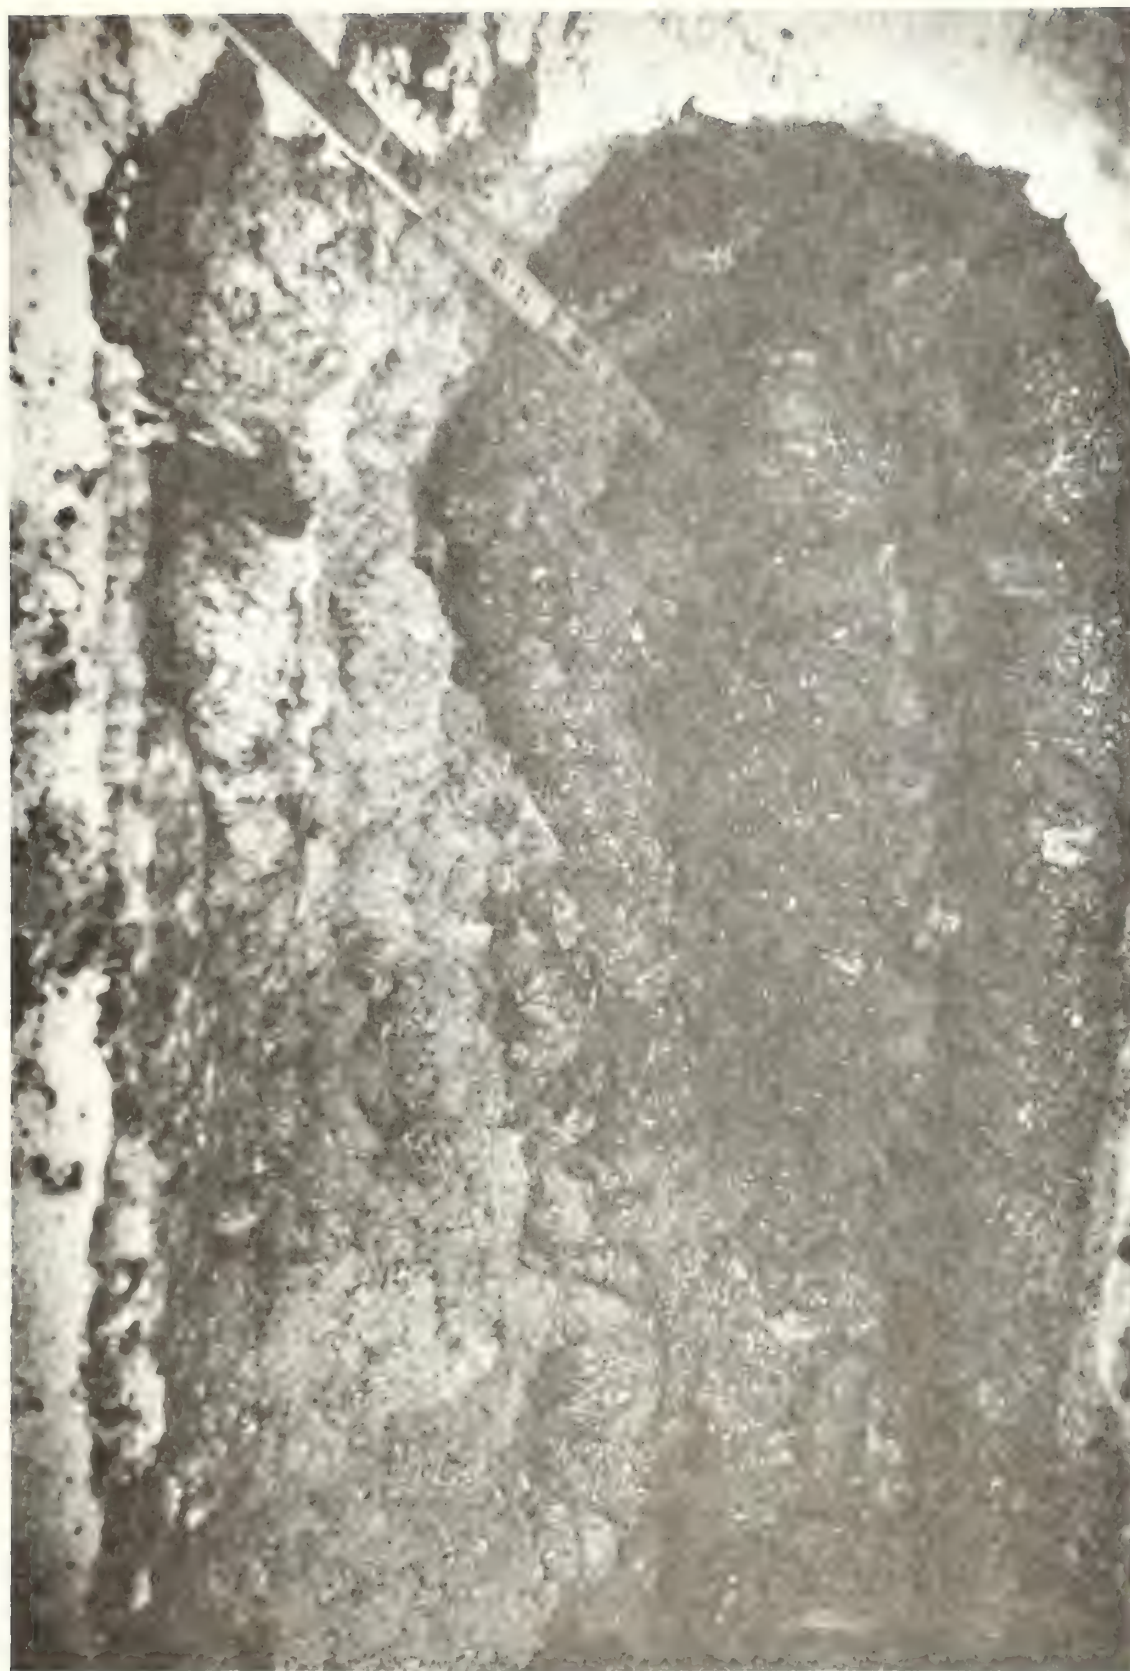
Illustration 25

Notice the courses of the face stones covering the tie rod and plates, particularly the lower which is being dislodged due to the plate exfoliation. The upper course appears intact although the same forces that caused the lower steel plate to exfoliate are at work on the upper set as well as the east face, and in time could cause similar problems.

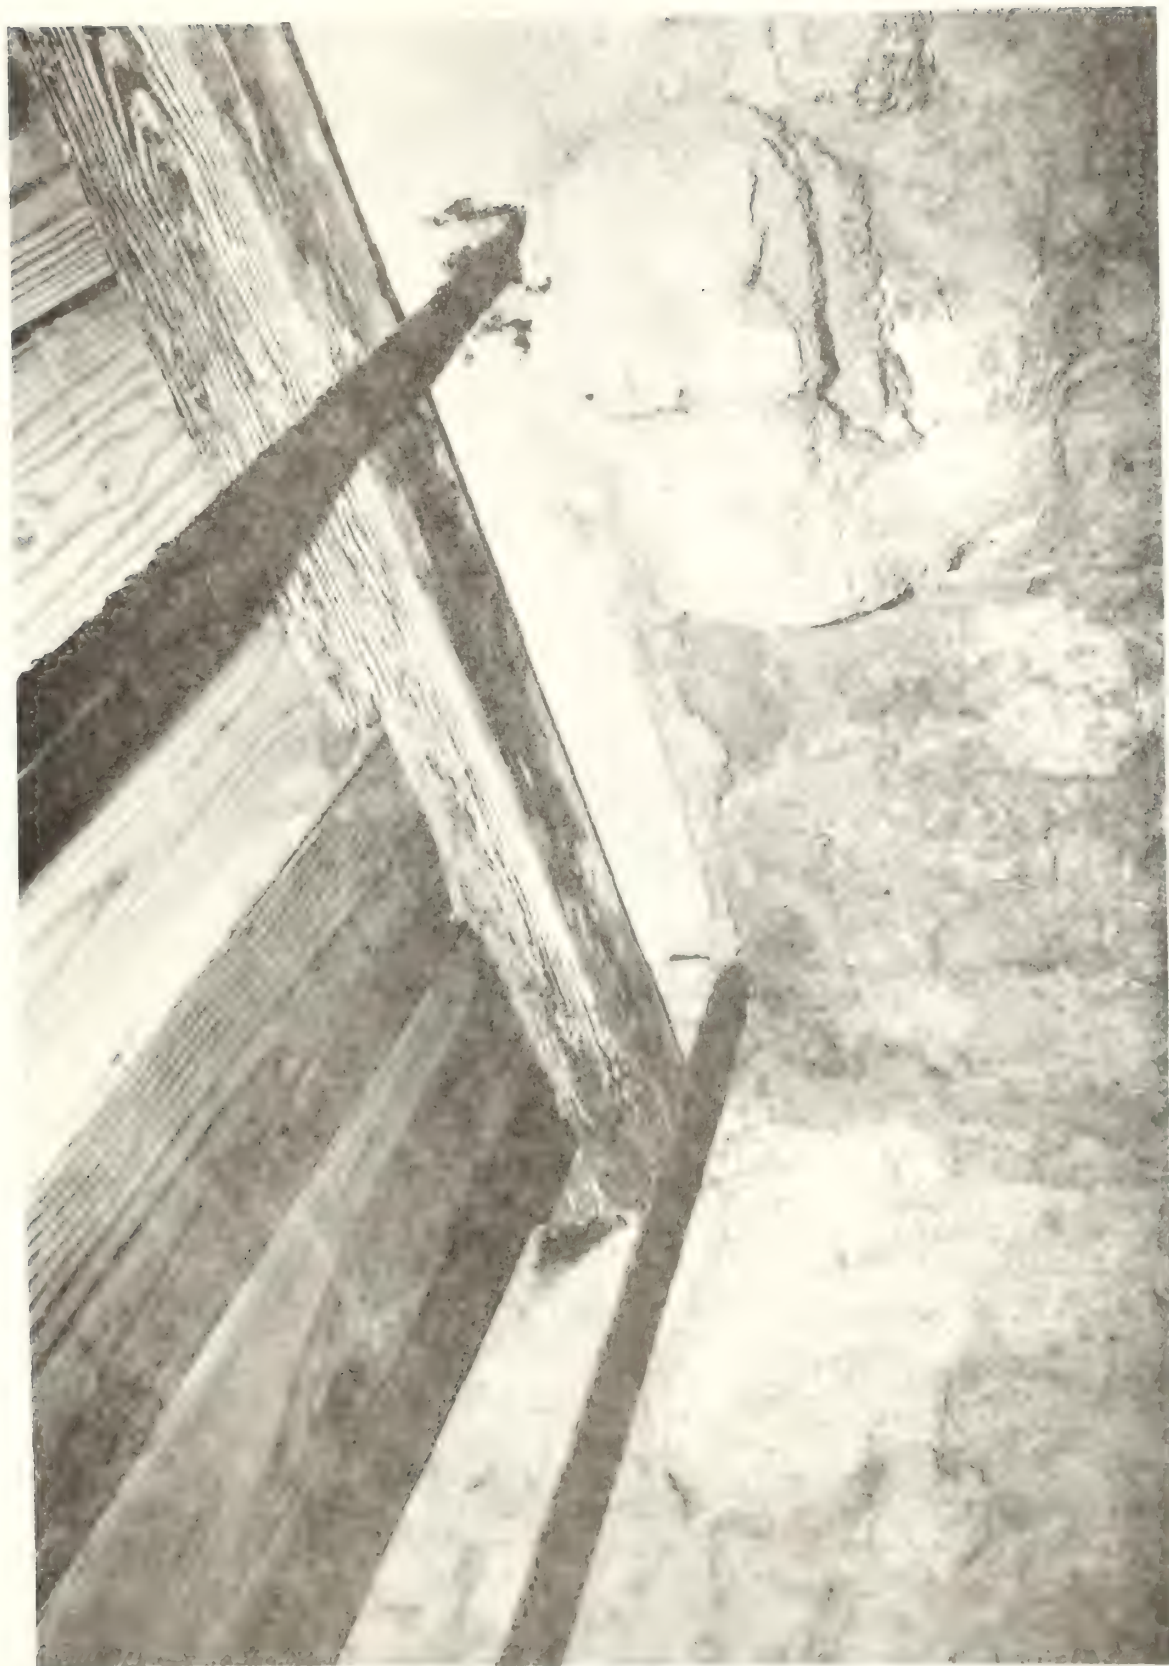
Illustration 27

Notice exfoliated iron.

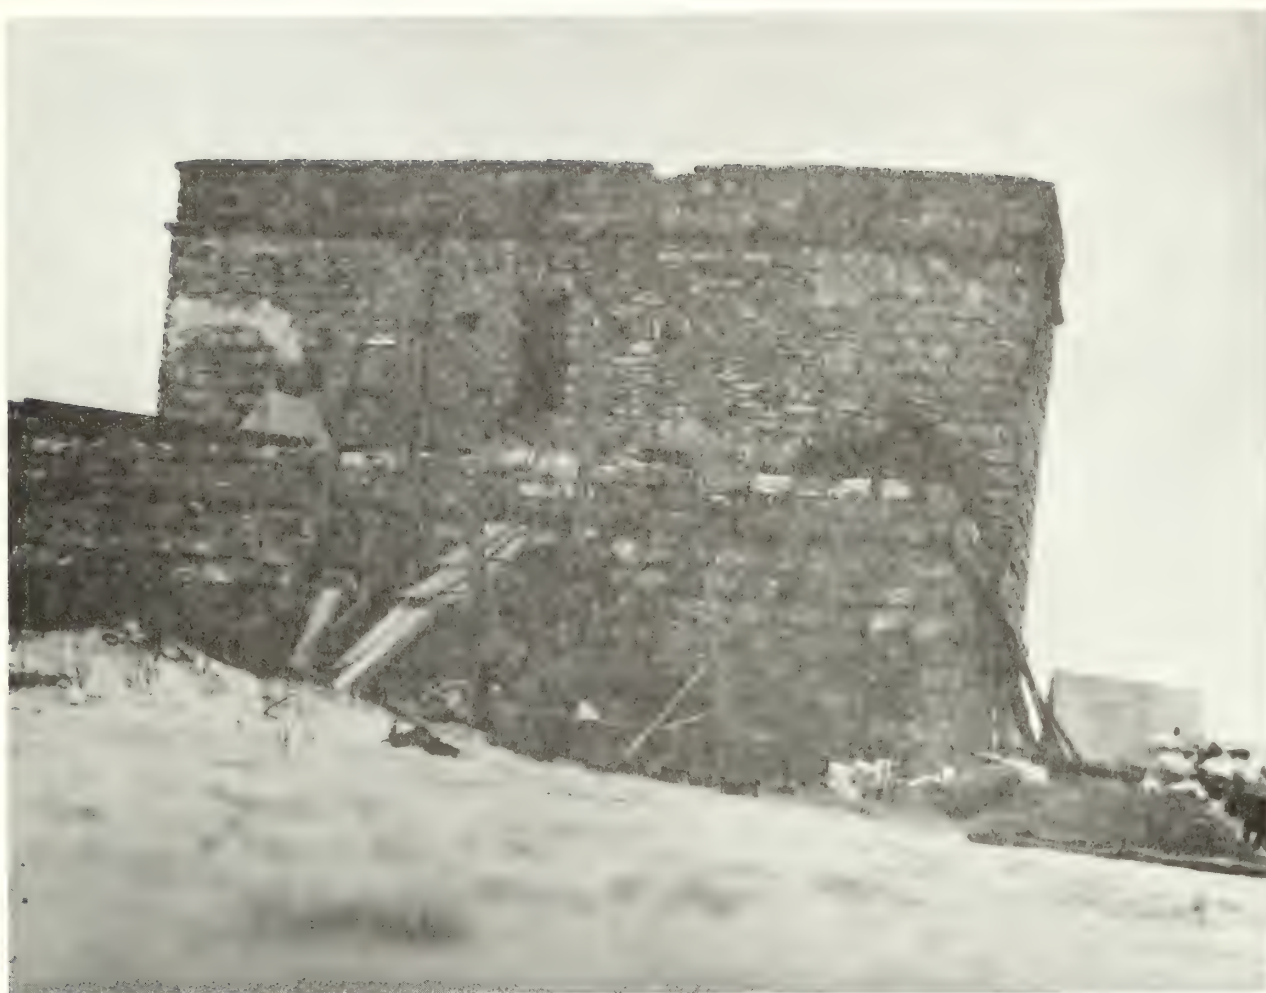
Illustration D-15

Contractor Bud Deyo is pictured here at the foot of the fort. It is interesting that the marsh mud fill of the base is dry enough to have cracked along with the shear failure of the south salient. It appears that the scarp wall is mostly rubble fill with cut stones forming the exterior face.

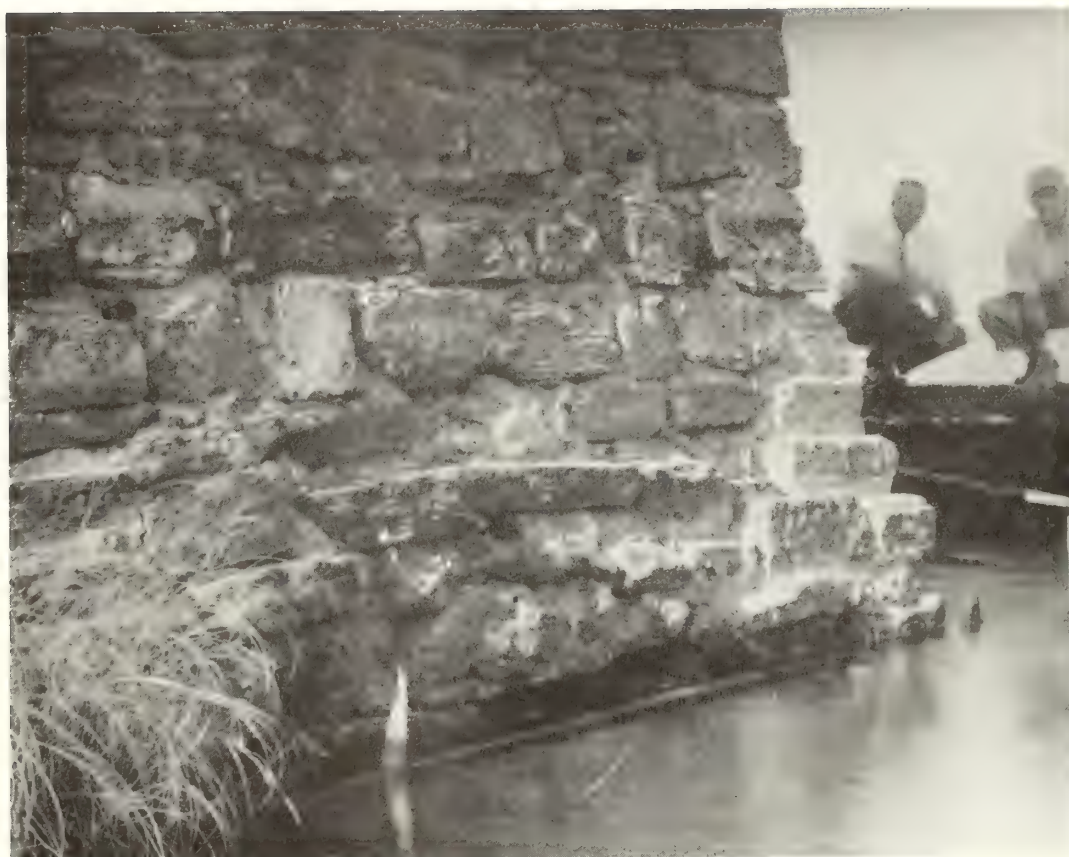
Illustration D-37

Taken in October 1947, this view shows that the southeast corner of the coquina sea wall and fill behind the wall has been removed by the storms of 1944 and 1947.

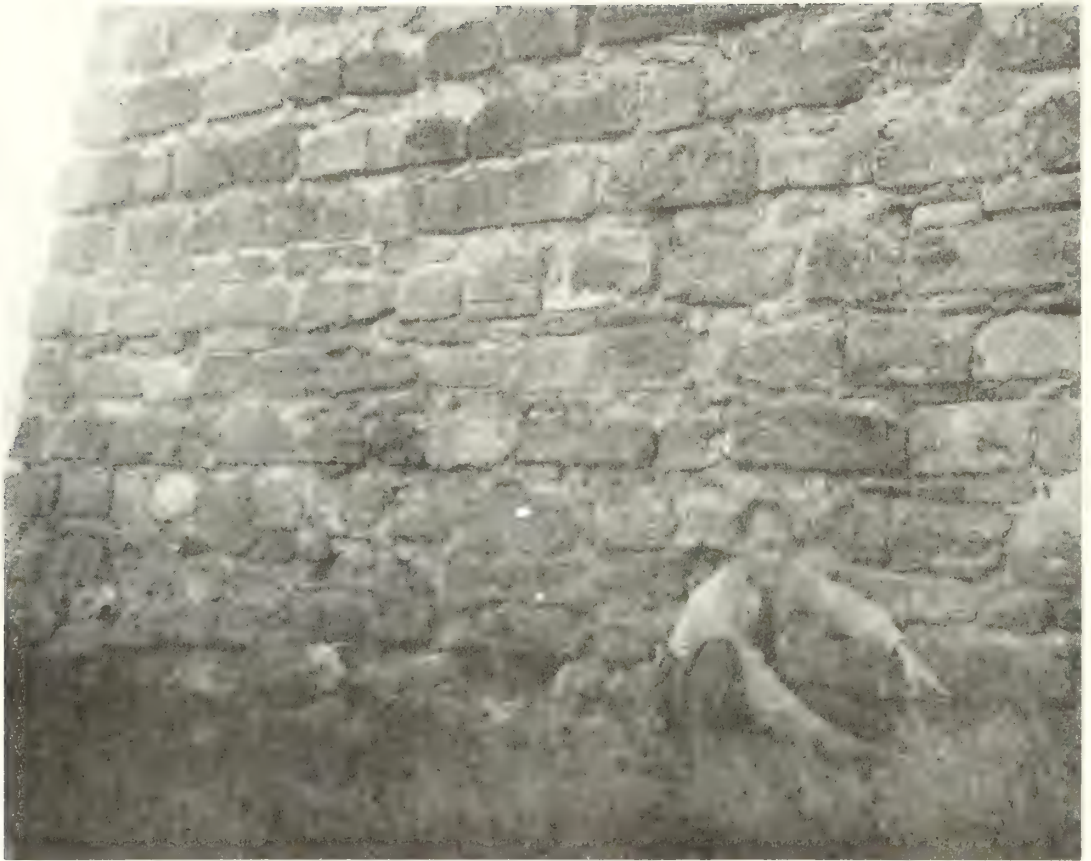
Illustration D-38

The storms of 1944 and 1947 removed a great deal of fill adjacent to the fort and as illustrated here, once again exposed the remains of the wooden foundation at the east salient. Notice that water is trapped between the steel sheet bulkhead and the base of the fort.

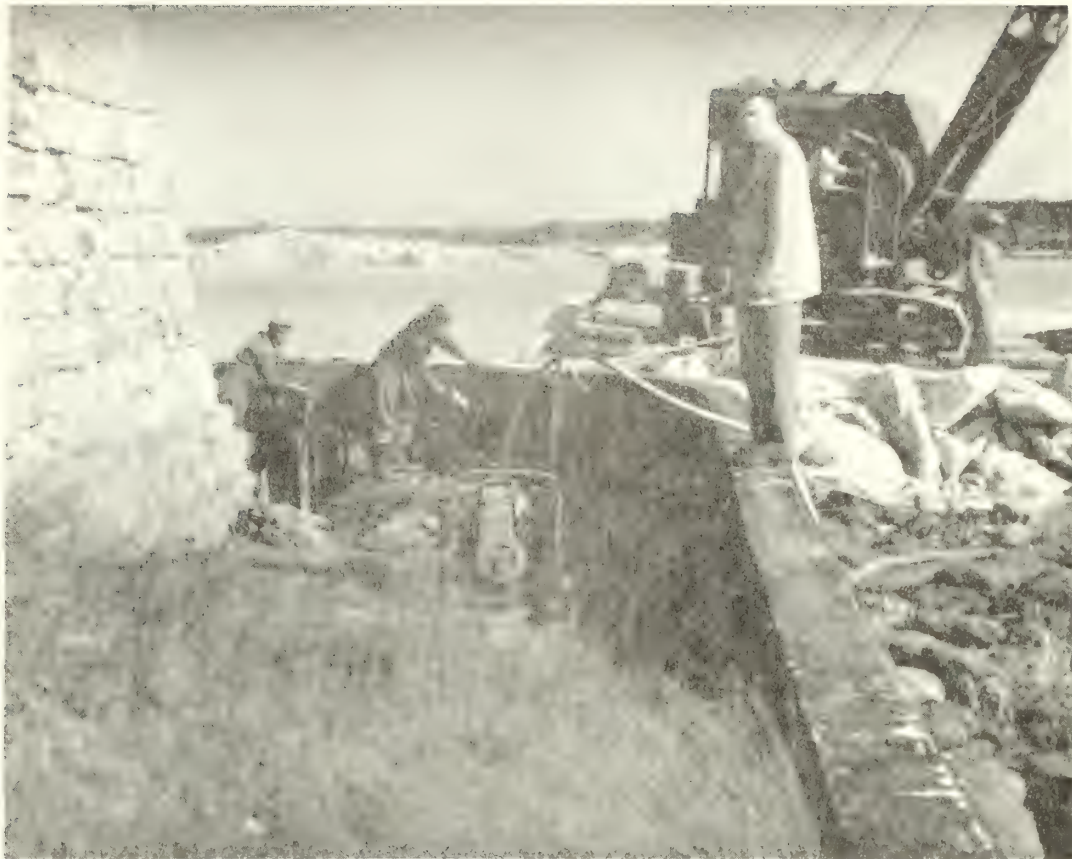
Illustration D-40

Massive riprap was used to repair the southeast corner of the fort site after the storms of 1944 and 1947 removed the coquina sea wall.

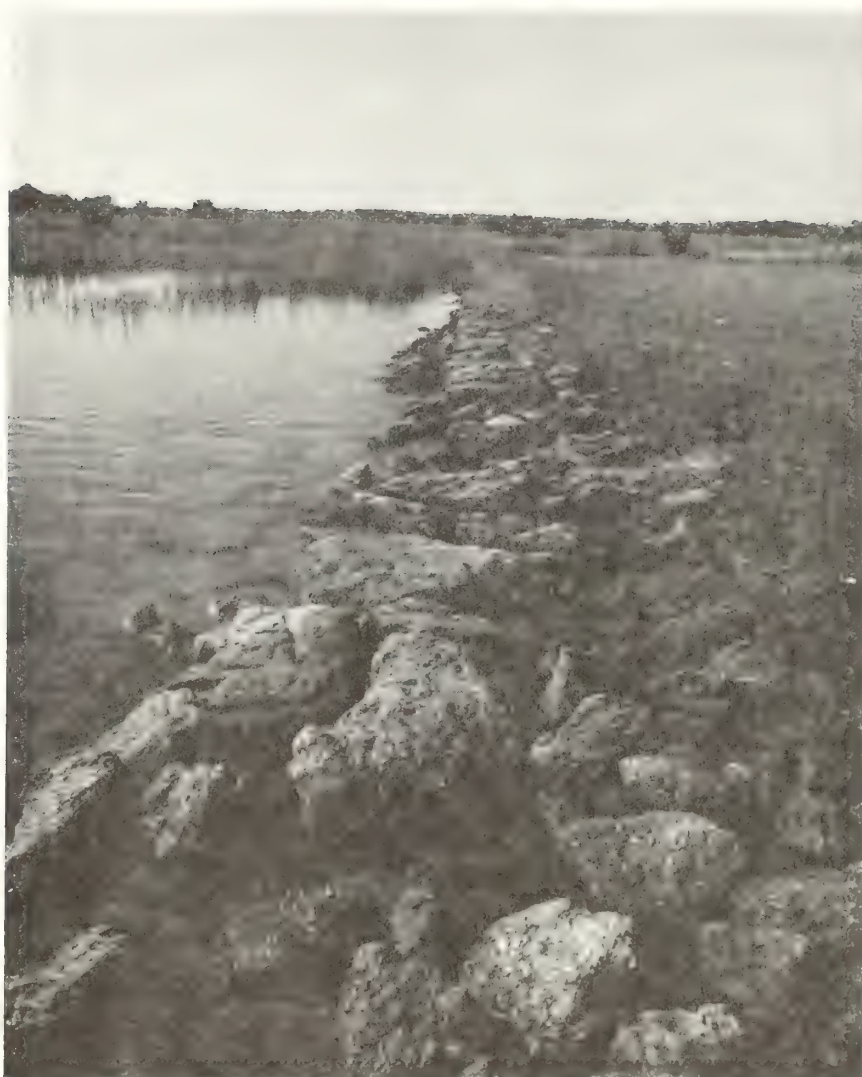
Illustration E-2

This seawall segment presently is covered by coquina riprap (Illus. E-2). Erosion on this side is minimal due to protection by the small island and the wall appears to be in stable condition.

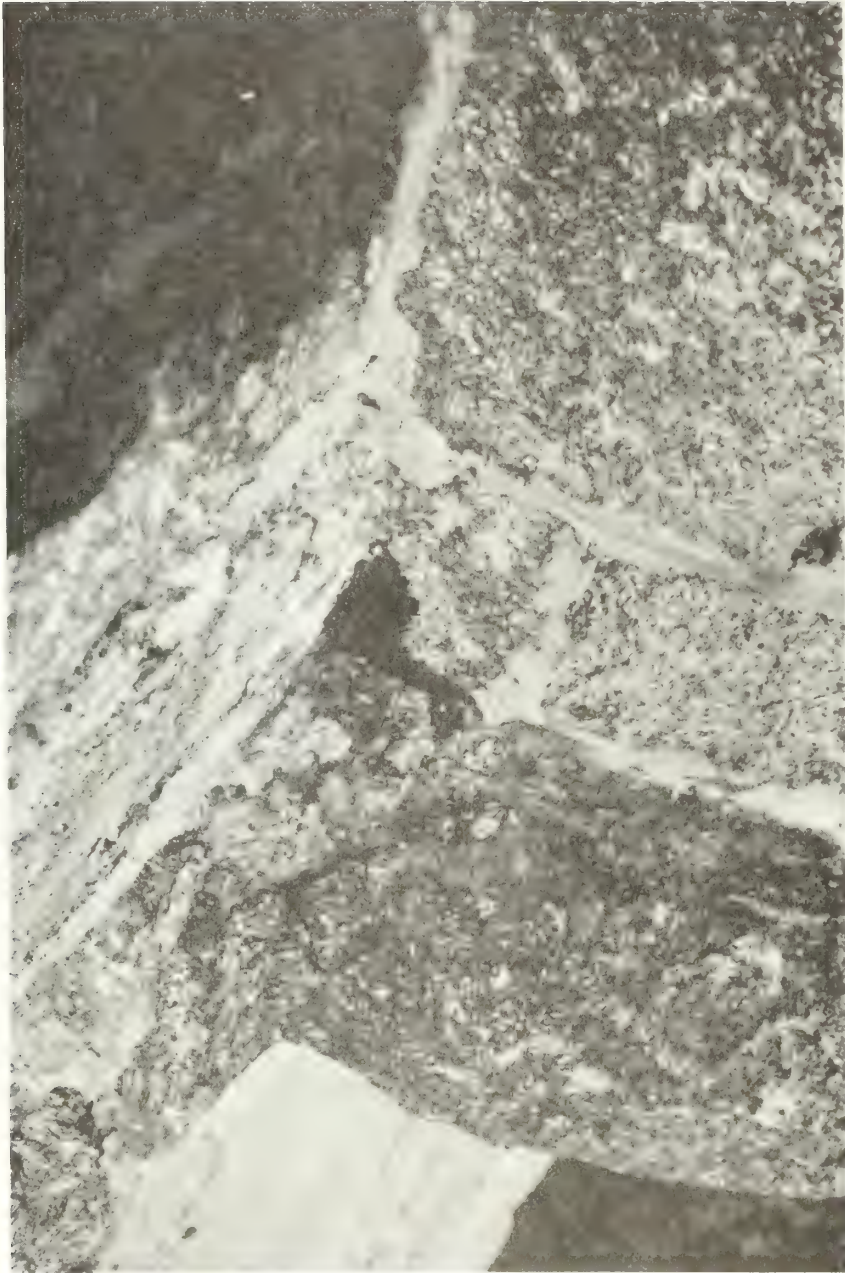
Illustration E-16

Detail of Steel Deterioration of Sentry Box Cordon

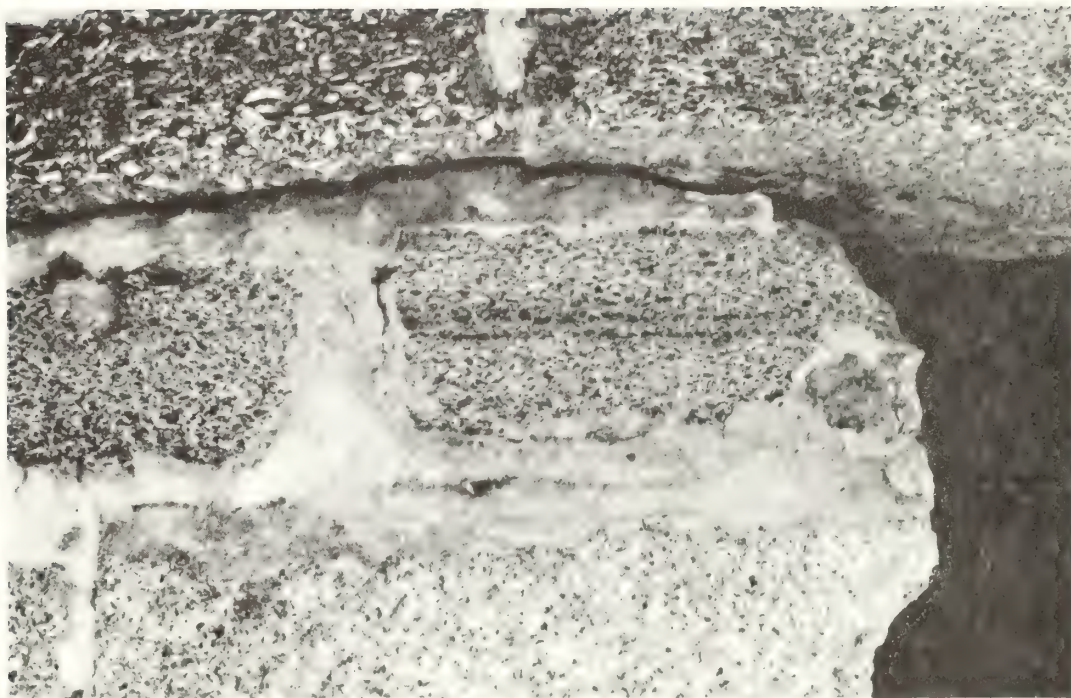
Illustration E-17
Detail of Steel Deterioration at Sentry Box Dome

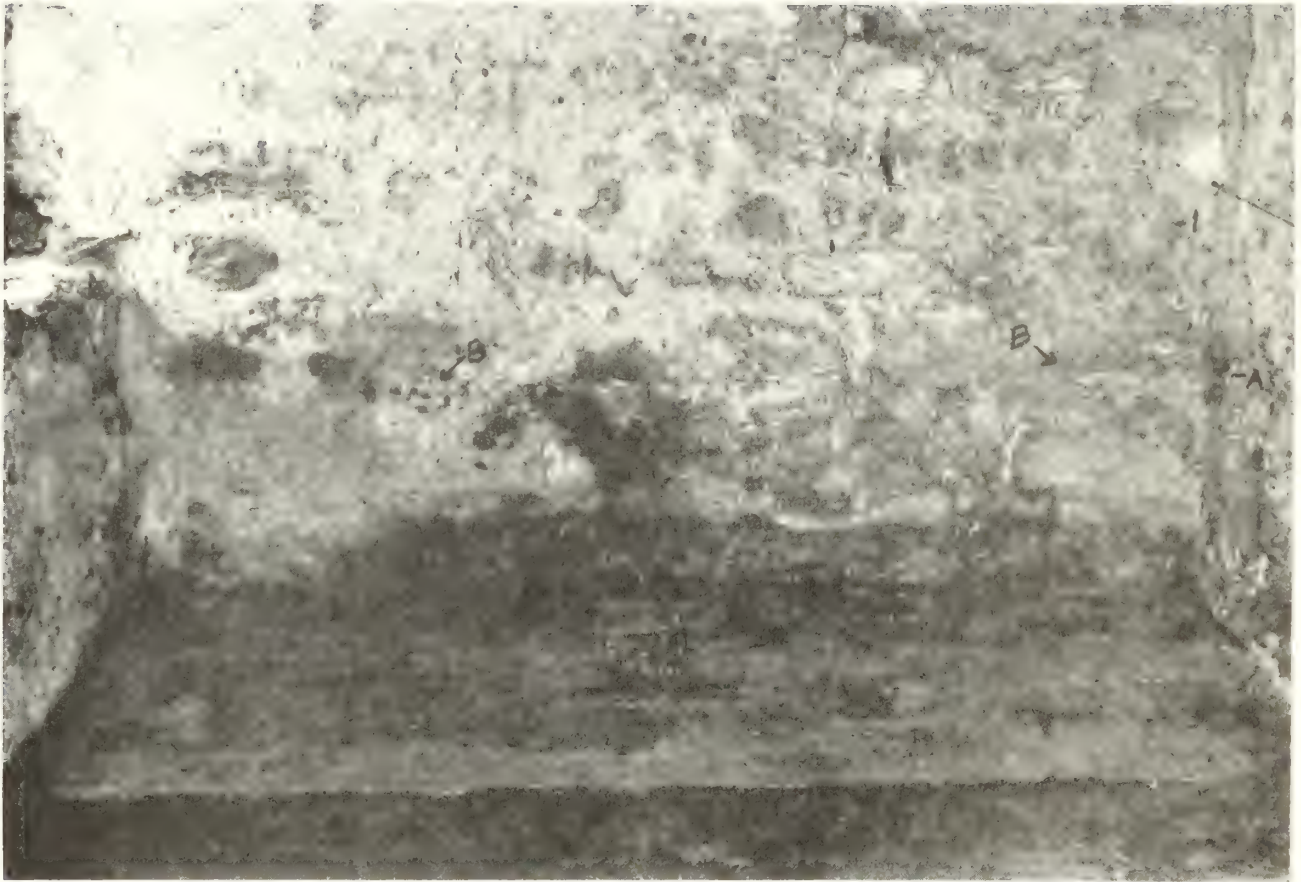
Illustration G-13
Above grade indication of wooden platform
A- Square holes in north wall
B- Sloping scar in west wall
C- postmold in Trench A
